The Bert Hinkler Accident.

Author Clive H Phillips

Retired Professional Aircraft Accident Investigator.

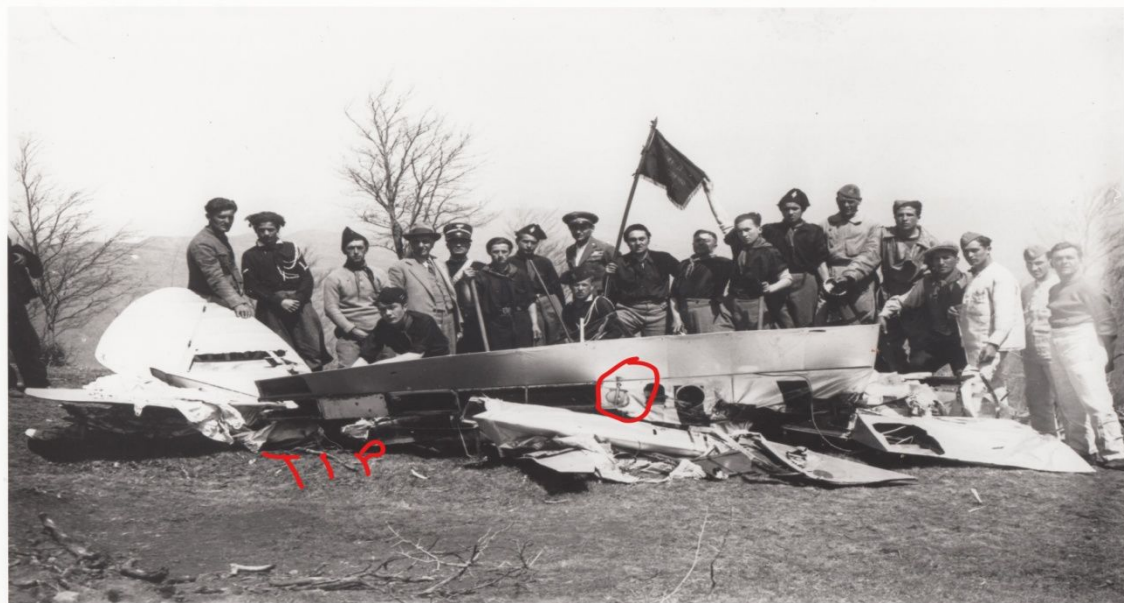
Photograph RB 11591/1

I have highlighted 'right wing' because the wreckage photographs only show the left wing, as seen here in photograph RB11591/1 in Data 8. I have circled the aileron sprocket and link which is on the lower surface of the wing, and have indicated the tip – the wing root is on the right of the photograph. As this is the lower surface of the wing it confirms that it is the left wing. Also note the wing tip is quite disrupted.

Mr. Ghedini stated "*the plane had collided with the right wing with some trees.*" However the right wing could not be identified within the wreckage photographs examined. Did Mr. Ghedini misidentify the wing in the wreckage, and was he not aware of the wing 250 yards (750 ft. / 228 meters) from the wreckage? It is more plausible that he saw the tip damage on the right wing, and that was what he was referring to.

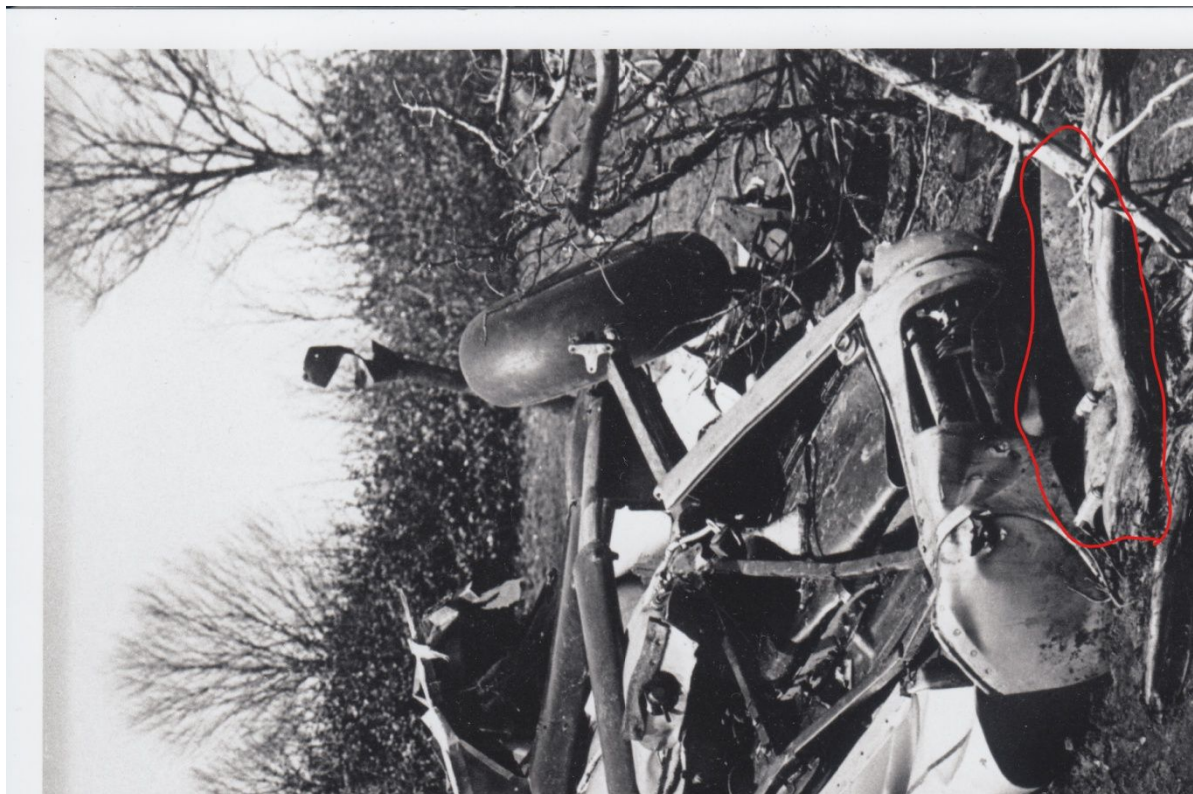
Photograph LD51/17

This Queensland Museum photograph LD51/17 contained with Data 8 is reproduced here and shows the engine, nose cowl and propeller. In the photograph the visible remains of the propeller are circled.

At the top of the photograph is the tip of one blade and at the bottom is the propeller hub with the other blade missing. The hub has the blade securing bolts on the one side of the hub still in place. The other side cannot be seen, however there appears to be no distorting of the hub which would have occurred had a blade been ejected in flight due to hub failure, or bolt looseness.

As previously mentioned, a site report states that one blade was in the ground for half its length. However this is not seen in any photographs. Nor can we adequately see the end of the hub where there is no blade in place. Therefore we cannot determine by what manner that blade was disrupted from the hub. The impact with the terrain was very severe as can be seen by the damage to the engine and adjacent structure.

It may be that later observers of this photograph could deduce that one blade was ejected from the hub however there are no site reports which point to one blade being missing. One would assume that at least Mr. Ghedini was sufficiently familiar with aircraft to have noted a missing blade.

In the event that a wing was separated from a fuselage in flight the resulting plunge to the terrain by the remaining wreckage would result in the propeller being the first assembly to impact terrain. The reported fact that one blade penetrated to half its depth is plausible. With the violence of the impact it is not surprising that the remainder of the propeller was dislodged in the subsequent severe disruptive forces, the results of which are seen in the photograph.
